Lee's Lane Landfill Louisville, Kentucky

prepared for
EPA Region 4
and OERR

TS-PIC-82068
November 1982

Steve Baker, Imagery Analyst
The Bionetics Corporation
Warrenton, VA 22186

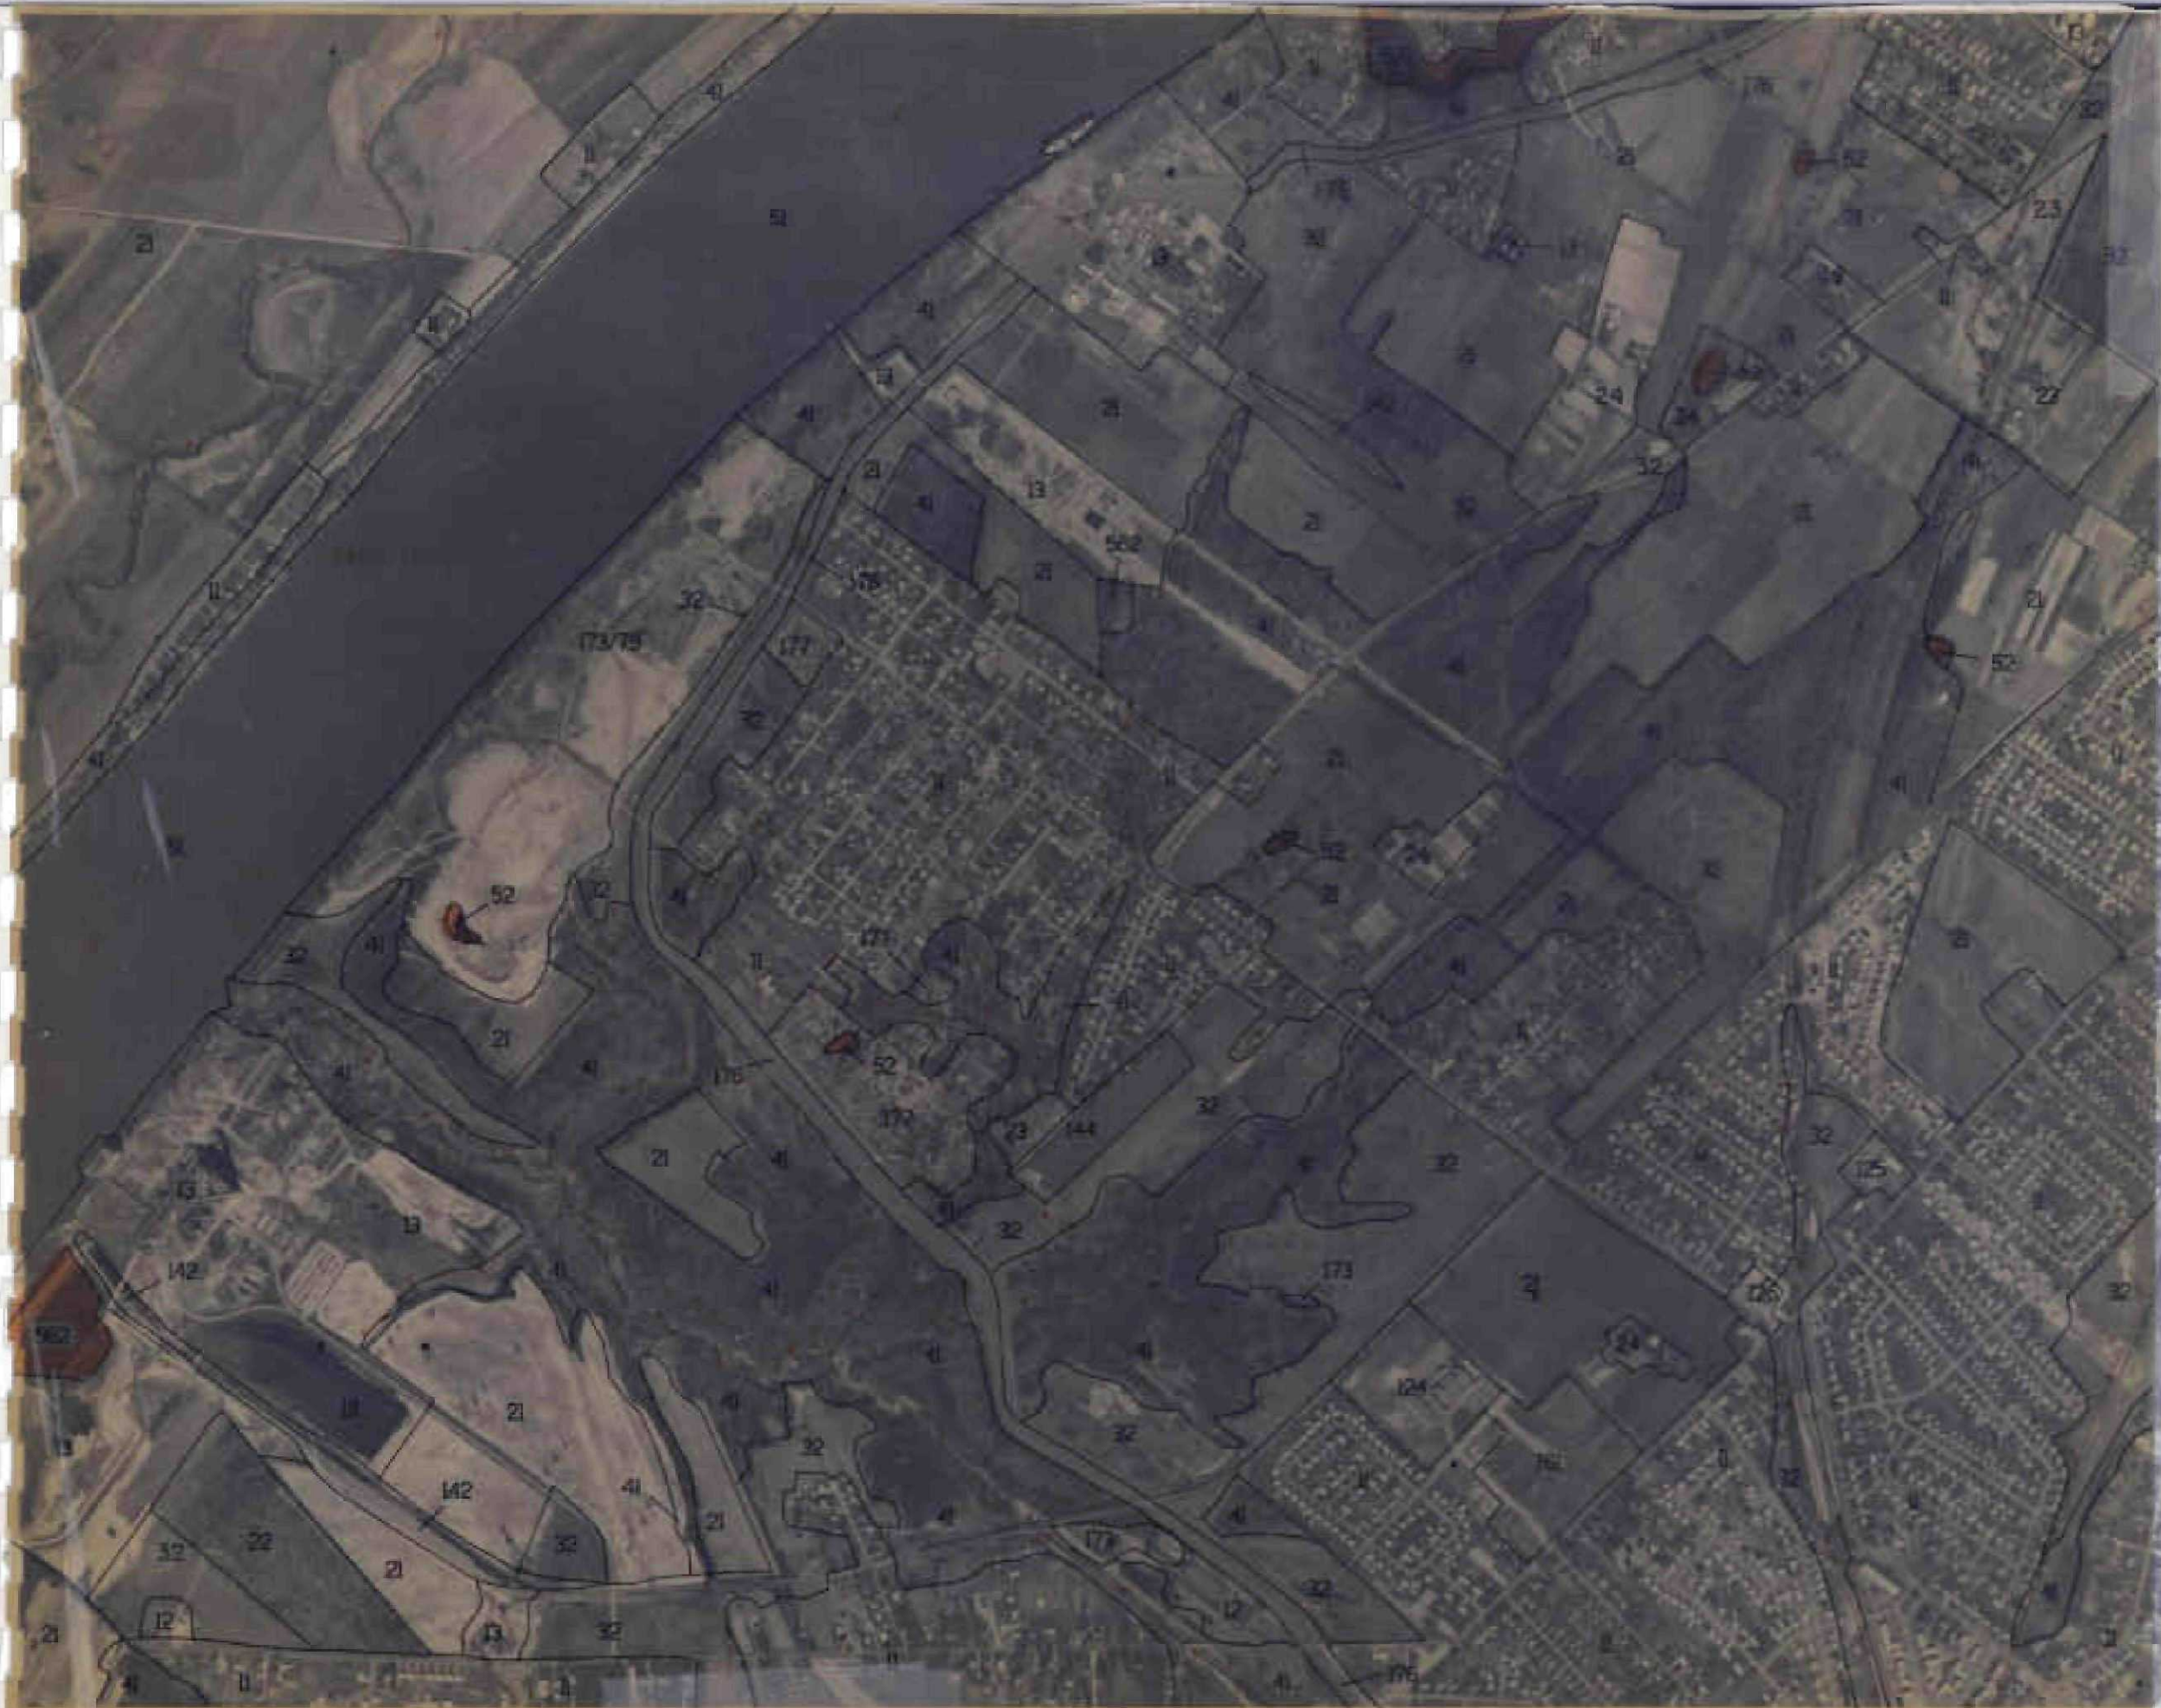
LAND USE SURVEY

This photo enlargement and its accompanying overlays show the various types of land use and drainage patterns surrounding the landfill site. The land use classification system used in this study was adopted from a United States Department of Interior publication¹ on land use identification using remotely sensed data. Minor modifications of the system were required to provide an accurate representation of land usage in the area.

The drainage survey denotes all detectable drainage and water body features in the vicinity of the landfill. Two small drainage channels flowing directly through or from the landfill have been detected and annotated on the overlay. The first channel appears to flow across the site and into the Ohio River. The second drainage course (a natural channel located in the southeast portion of the site) flows from the perimeter of the landfill into Mill Creek Cutoff. No detectable evidence indicating the presence of waterborne pollutants was noted in or around either of these drainage channels.

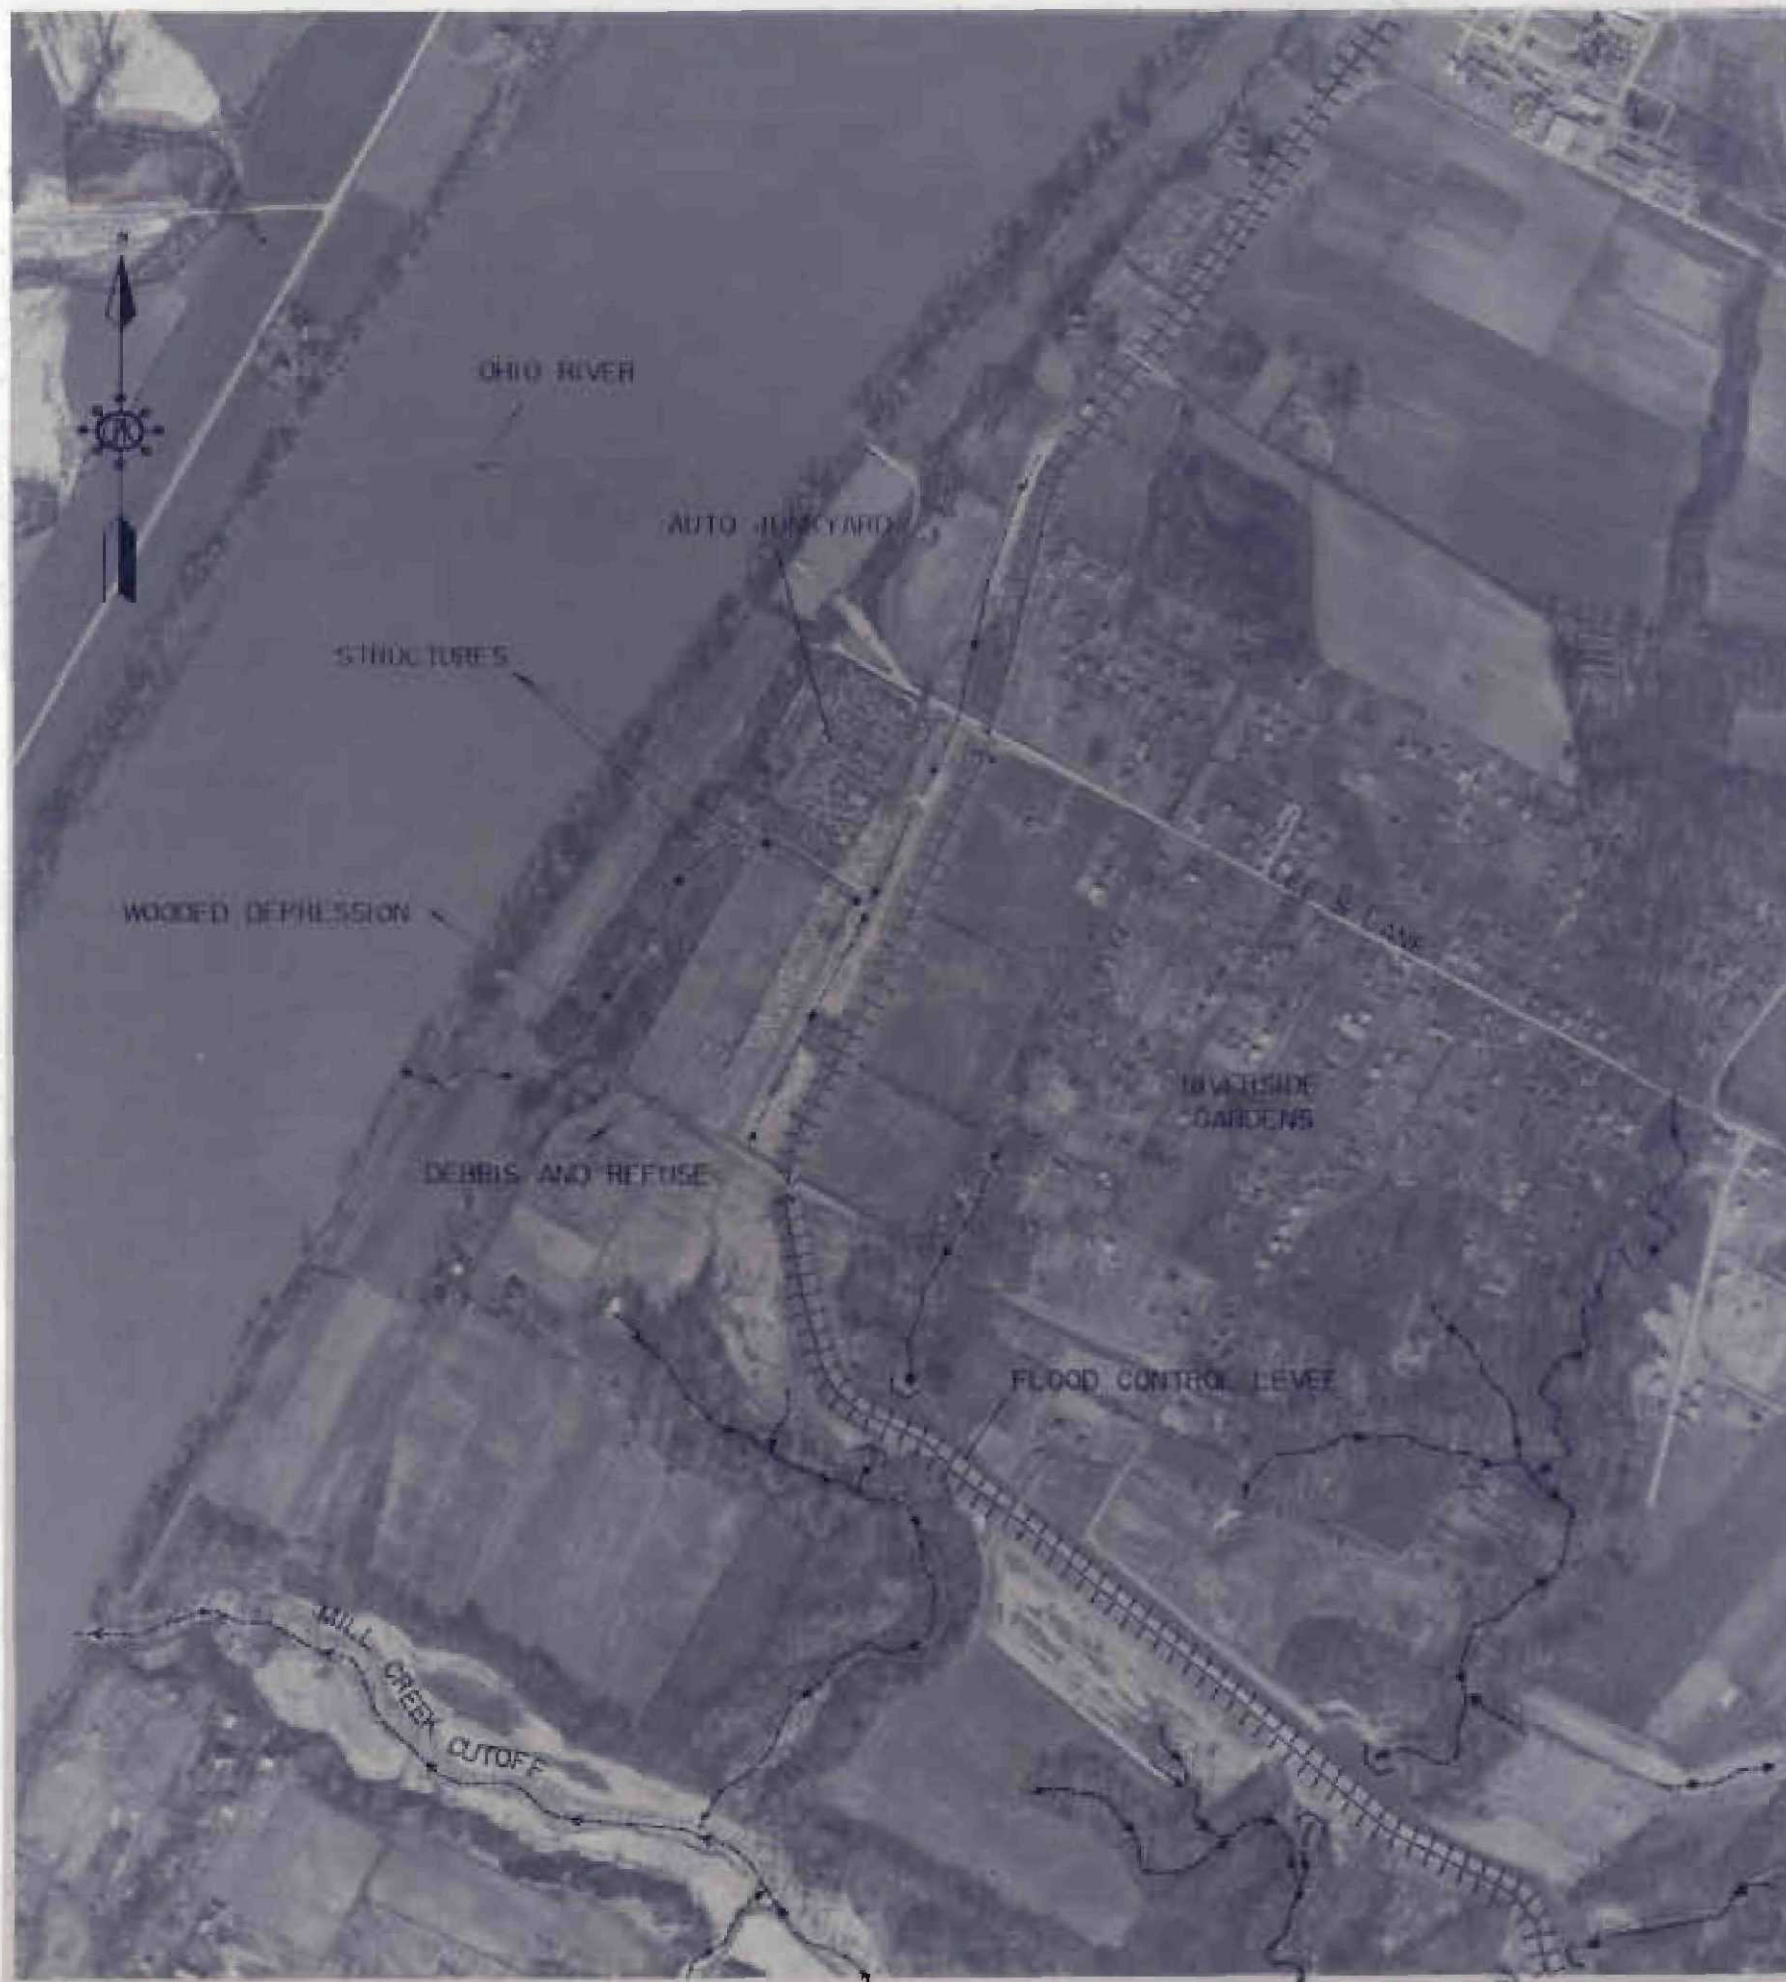
LEE'S LANE LANDFILL FEBRUARY 15, 1955 APPROX. SCALE 1:8,000

A large, well-established auto junkyard occupies most of the Lee's Lane Site in 1955. Monoscopic photo analysis does not reveal any evidence indicating suspicious materials or activities are being handled or conducted within the junkyard itself. A substantial quantity of debris and refuse material, however, has been located on a narrow strip of land lying south and east of the yard. This material has a highly mottled and light-toned appearance. The composition of this material cannot be determined from the photo.

Drainage in the immediate vicinity of the Lee's Lane Site is restricted to a system of natural and man-made drainage channels running in and around the site. A large linear channel, paralleling the adjacent flood control levee, appears to collect runoff from the surrounding acreage and channel it westward to the Ohio River. A second channel, bisecting the Lee's Lane Site, flows westward until it joins a natural drainage course which runs through a wooded depression and into the Ohio River. In later years this depression becomes a large waste disposal and fill site.

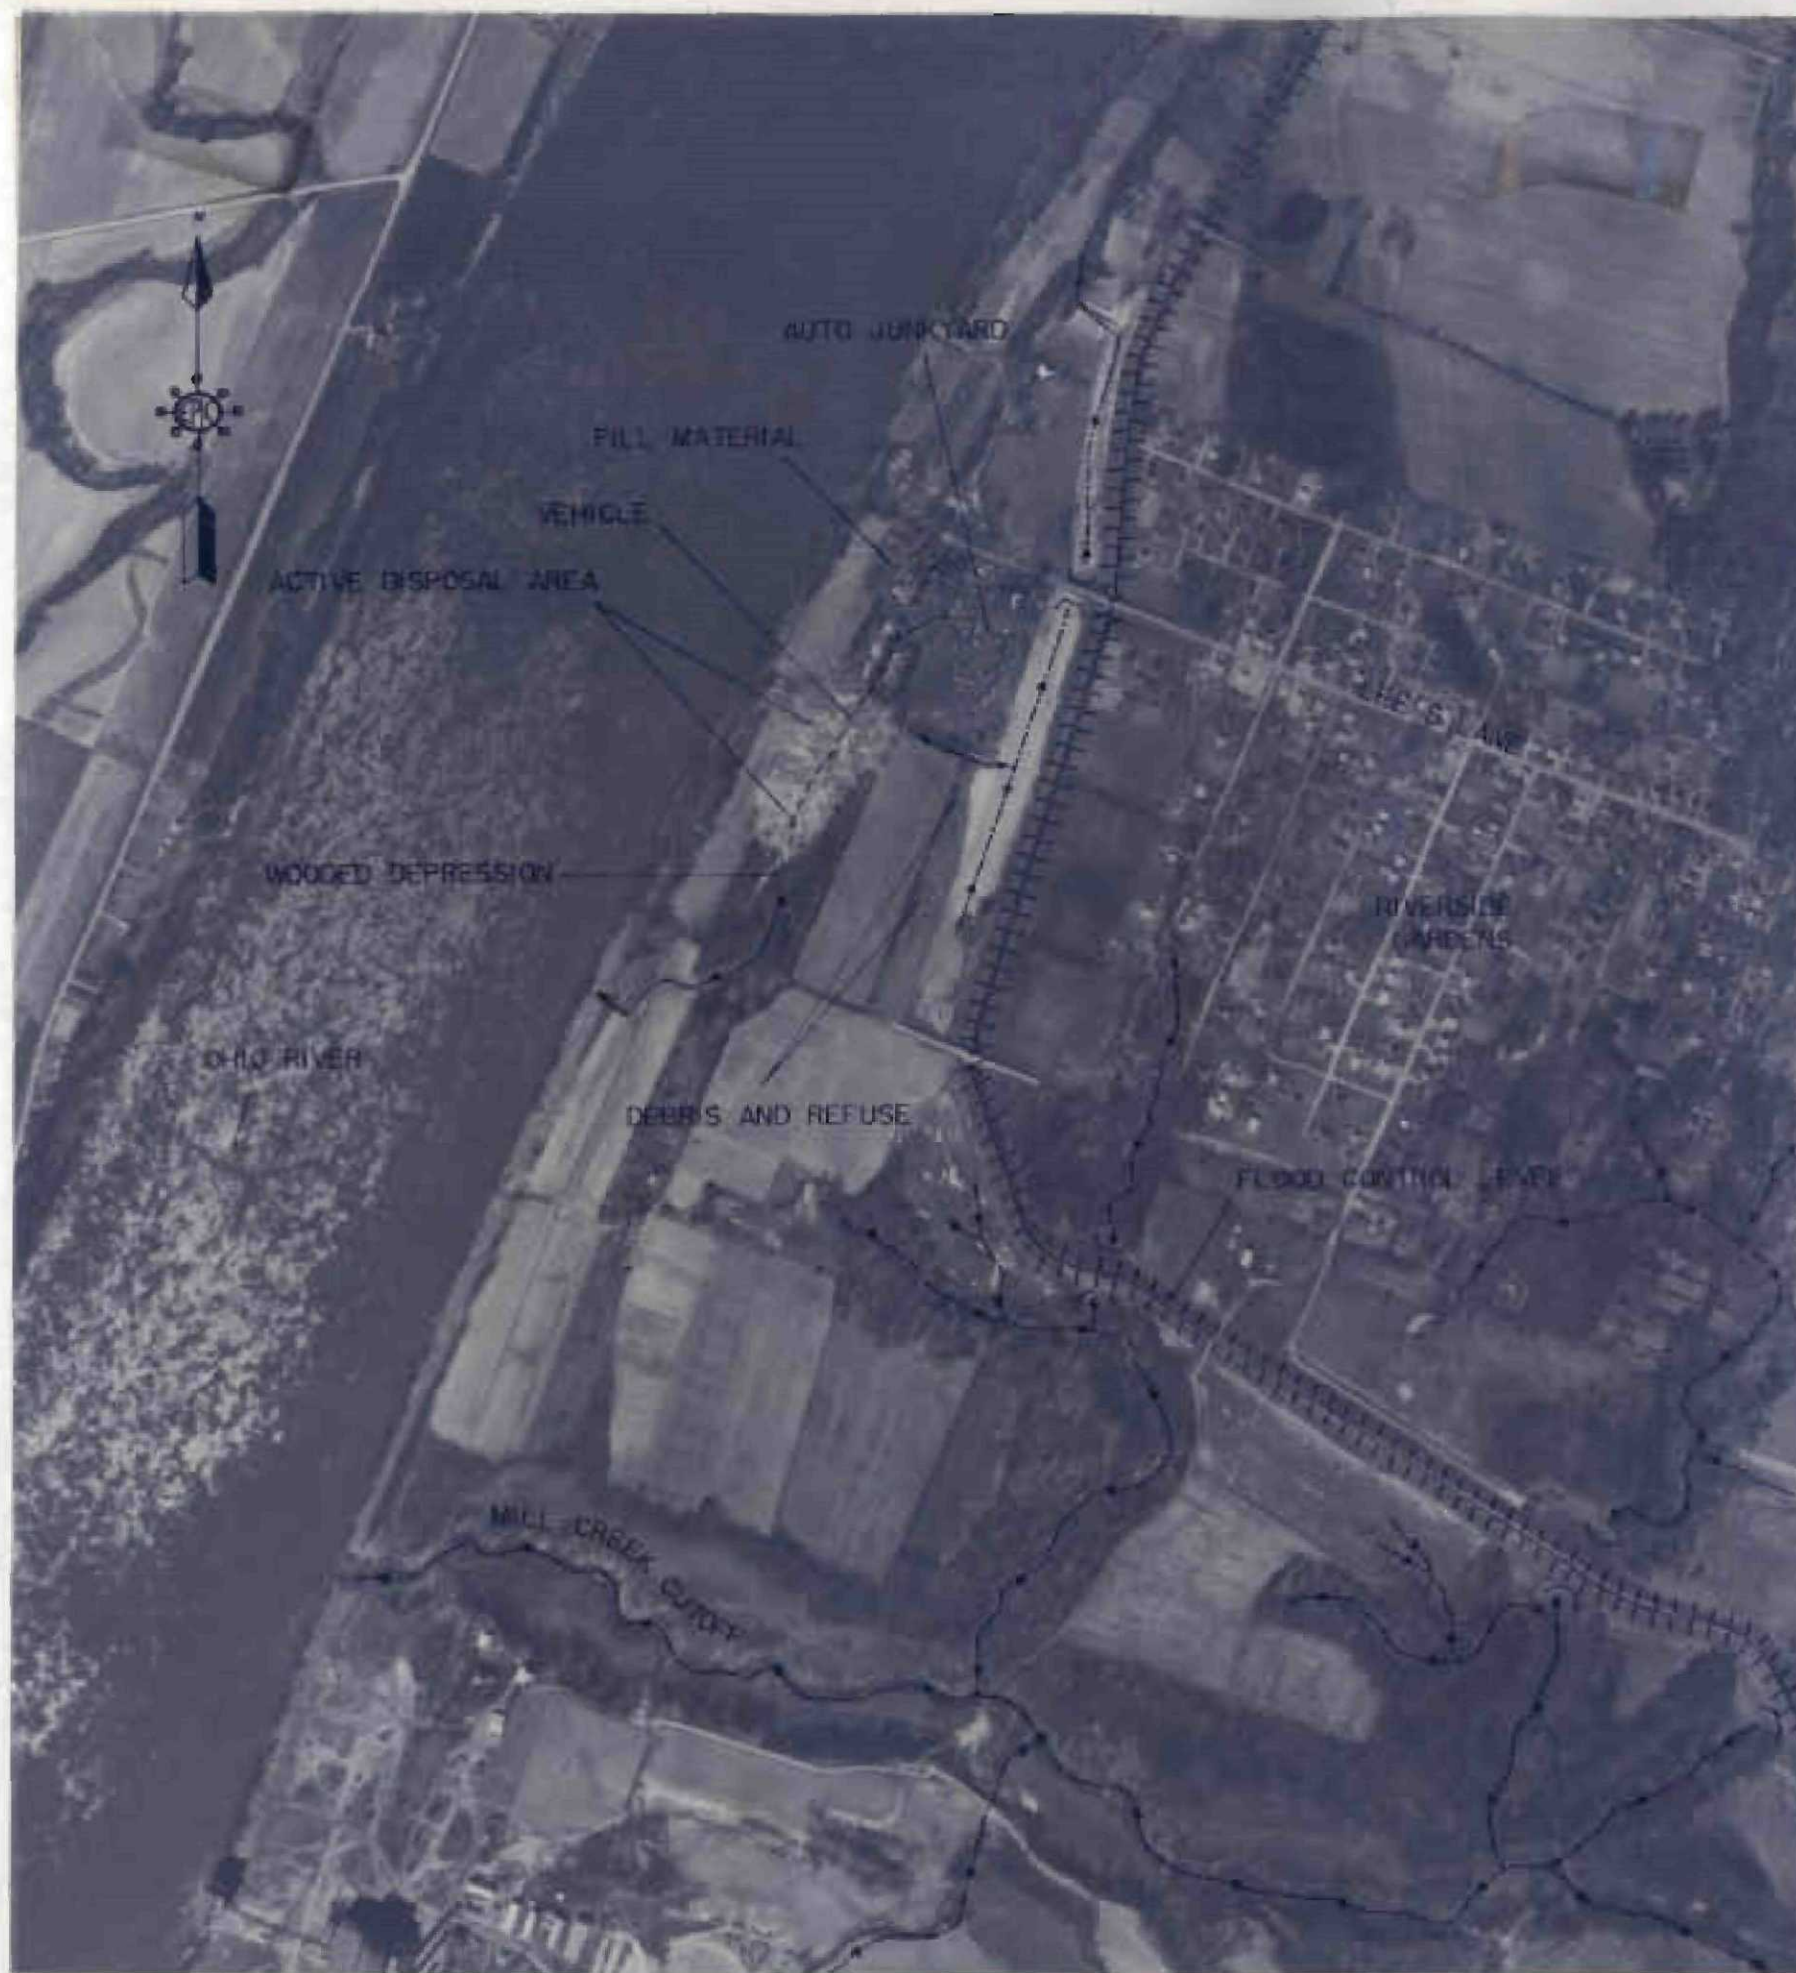
LEE'S LANE LANDFILL APRIL 4, 1959 APPROX. SCALE 1:8,100

Recent landfilling and disposal activities are clearly visible west of the auto junkyard. Most of the materials located in this area have a mottled, light-toned appearance characteristic of municipal wastes and recently deposited fill soil. The actual composition of these materials cannot be determined from the photo.

Access to this new landfill area appears to be limited to an ill-defined access road leading from Lee's Lane through the center of the disposal area. Additional access from the junkyard has also been detected. A lone vehicle, located near the center of the landfill, has also been identified in this area.

Residual quantities of debris and refuse materials located south of the auto junkyard (first detected in 1955) are still evident in 1959. Most of this material appears to have been removed, leaving only the extreme southern portion of the disposal area untouched. No new deposits of debris or refuse material have been identified in this area.

Disposal activity has greatly altered the drainage pattern in the immediate vicinity of the site. Landfilling activity in the northern portion of the wooded depression appears to have blocked the direction of drainage flow shown on the 1955 photograph. The drainage system now appears to flow northward alongside the drainage that parallels the flood control levee. This channel, which has recently been cleared or improved (as evidenced by its highly reflective, light-toned appearance), does not appear to drain into the Ohio River.

A significant decrease in the number of junked autos on site suggests that auto disposal and salvage activities are being curtailed. Complete termination of such activity occurs by 1971.

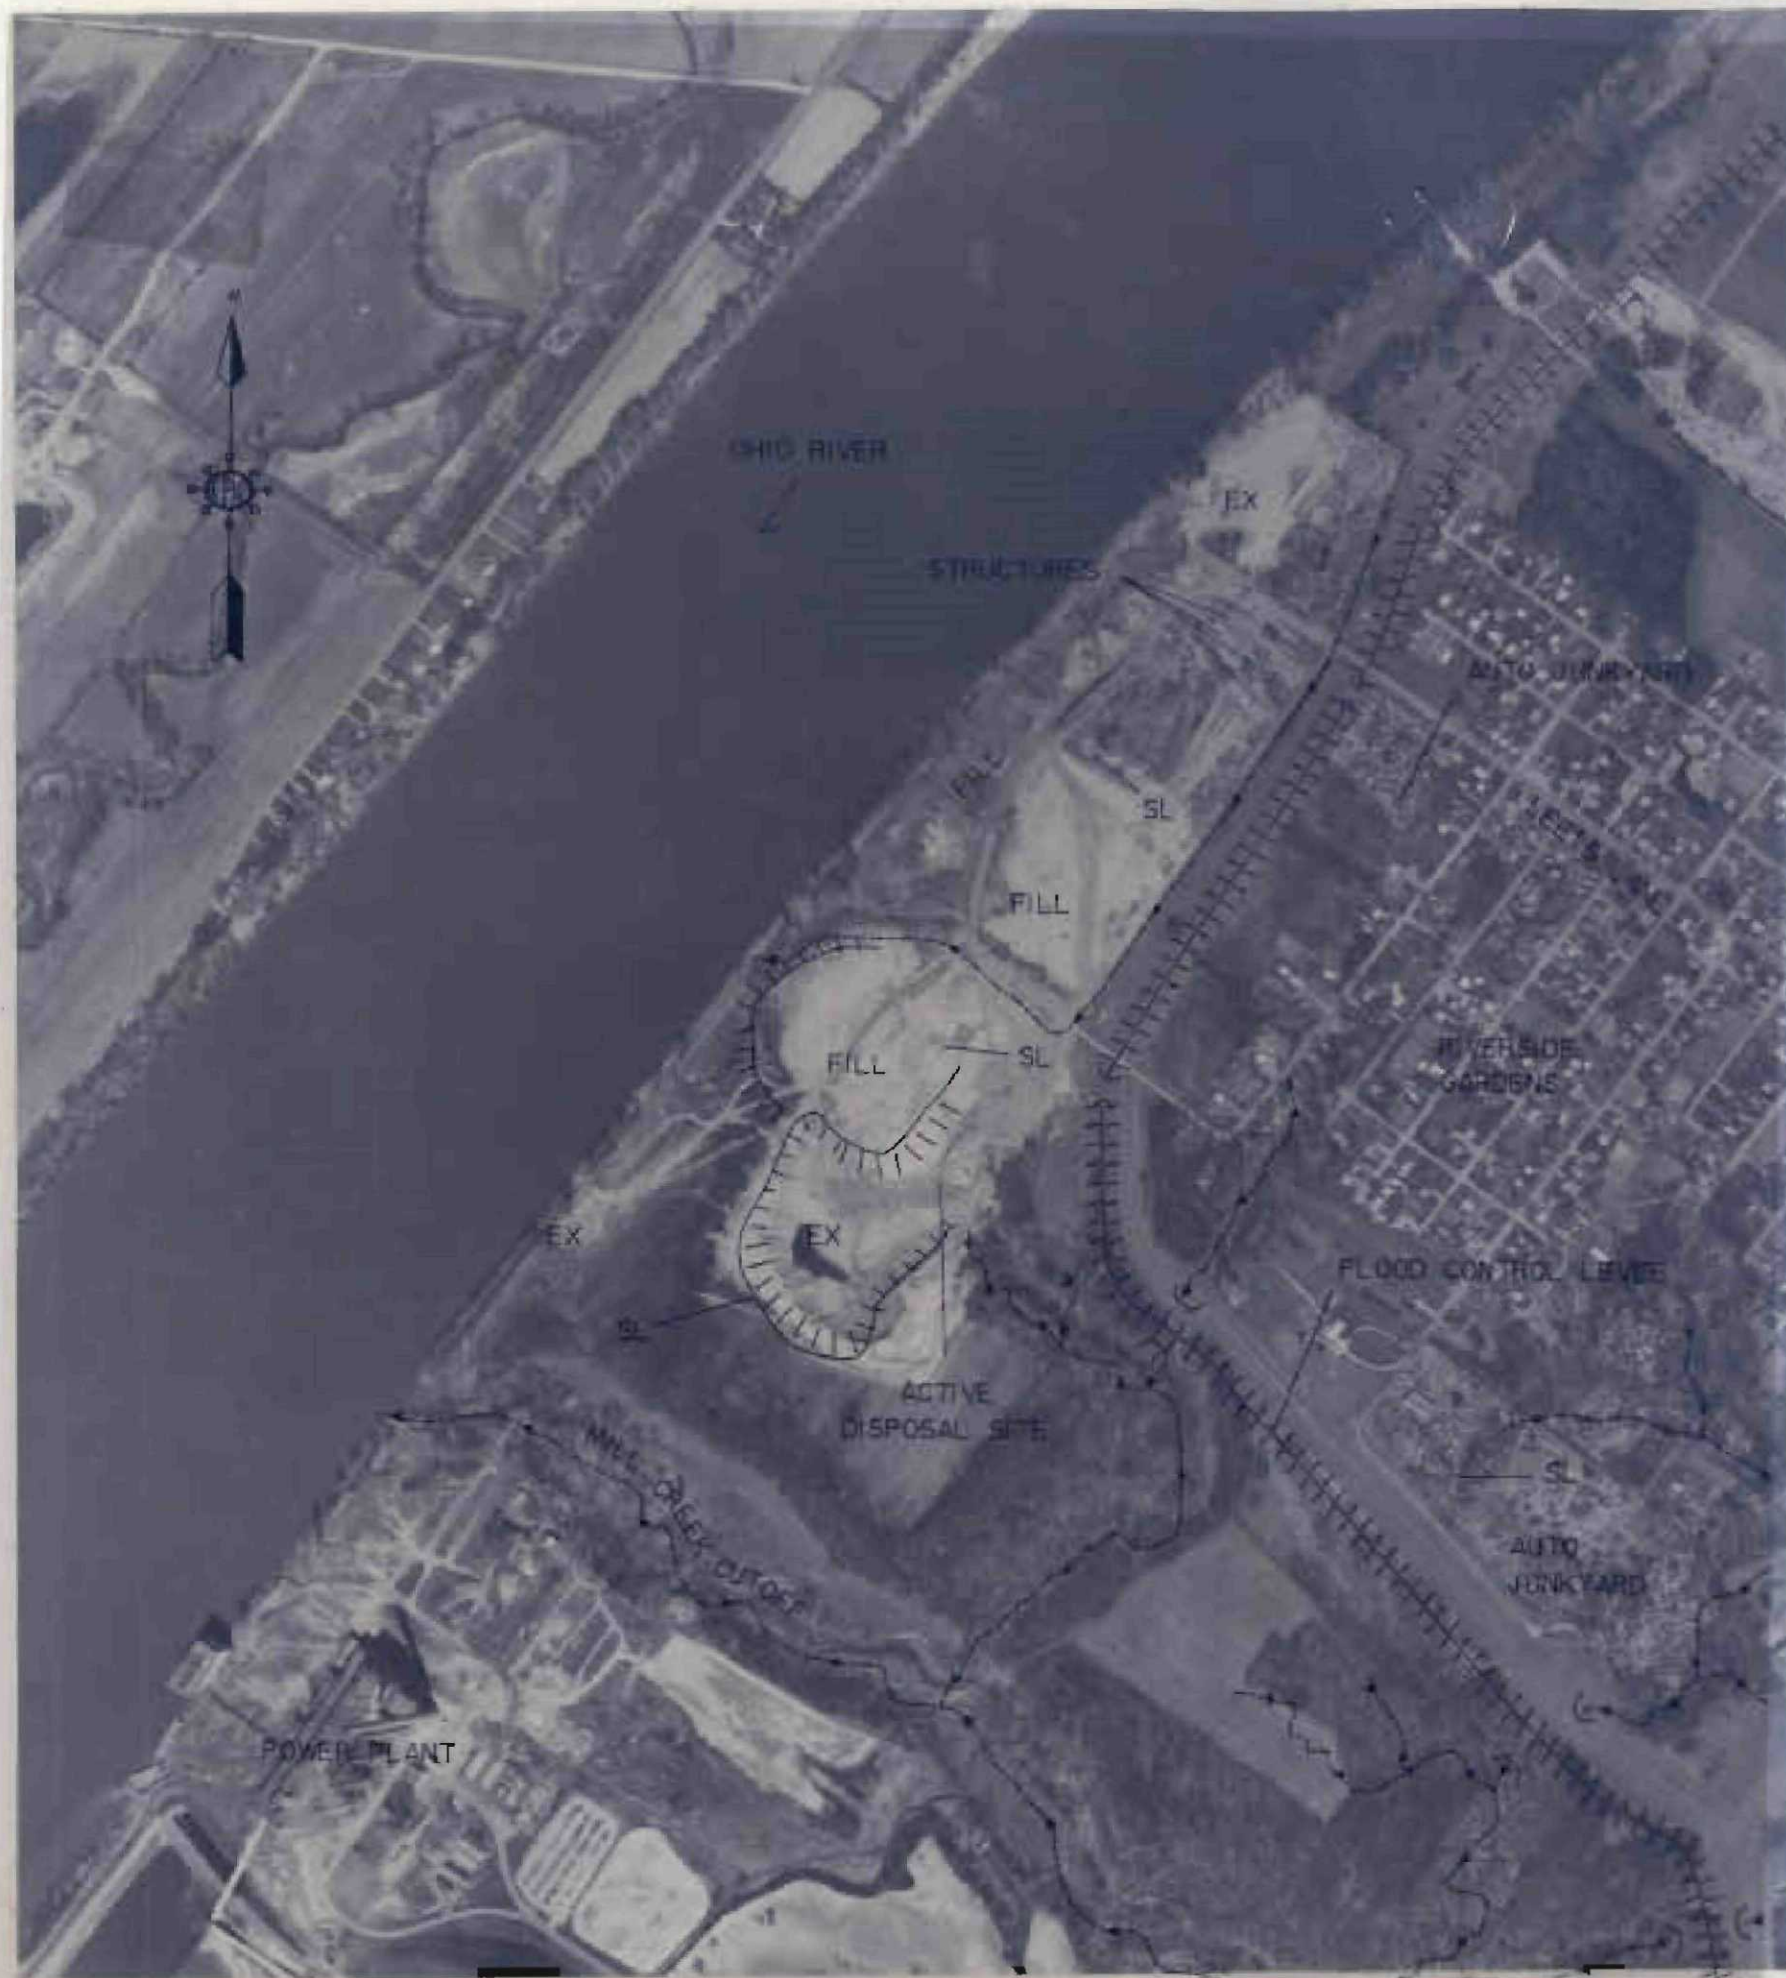
LEE'S LANE LANDFILL MARCH 30, 1971 APPROX. SCALE 1:8,500

Significant disposal and extraction activity has greatly altered the size and appearance of the site since 1959. Large fill areas and extraction activity (probably sand and gravel oriented) now appear in the southern portion of the landfill. Ongoing disposal activity occurs at the southeastern portion of the site (adjacent to the excavation). The auto junkyard previously located in the northern portion of the site has been removed. Several structures, vehicle parking and a small extraction pit now appear to be the only significant features in this portion of the landfill.

The on-site drainage channel once again appears to flow southward into the Ohio River. The portion of the channel that crosses the site is located further south than its 1955 counterpart. An additional natural drainage channel now flows from the southeastern flank of the landfill into Mill Creek Cutoff. This channel's origin is located near the current active disposal site.

An additional outlying excavation appears along the banks of the Ohio River southwest of the landfill; several access roads connect this to the Lee's Lane Site. No significant features or activities were noted in this area.

Three large bodies of standing liquid (SL) appear in the central and southern portions of the landfill. These bodies of liquid were probably formed by precipitation and localized runoff and are not suspected indicators of leachate collection.

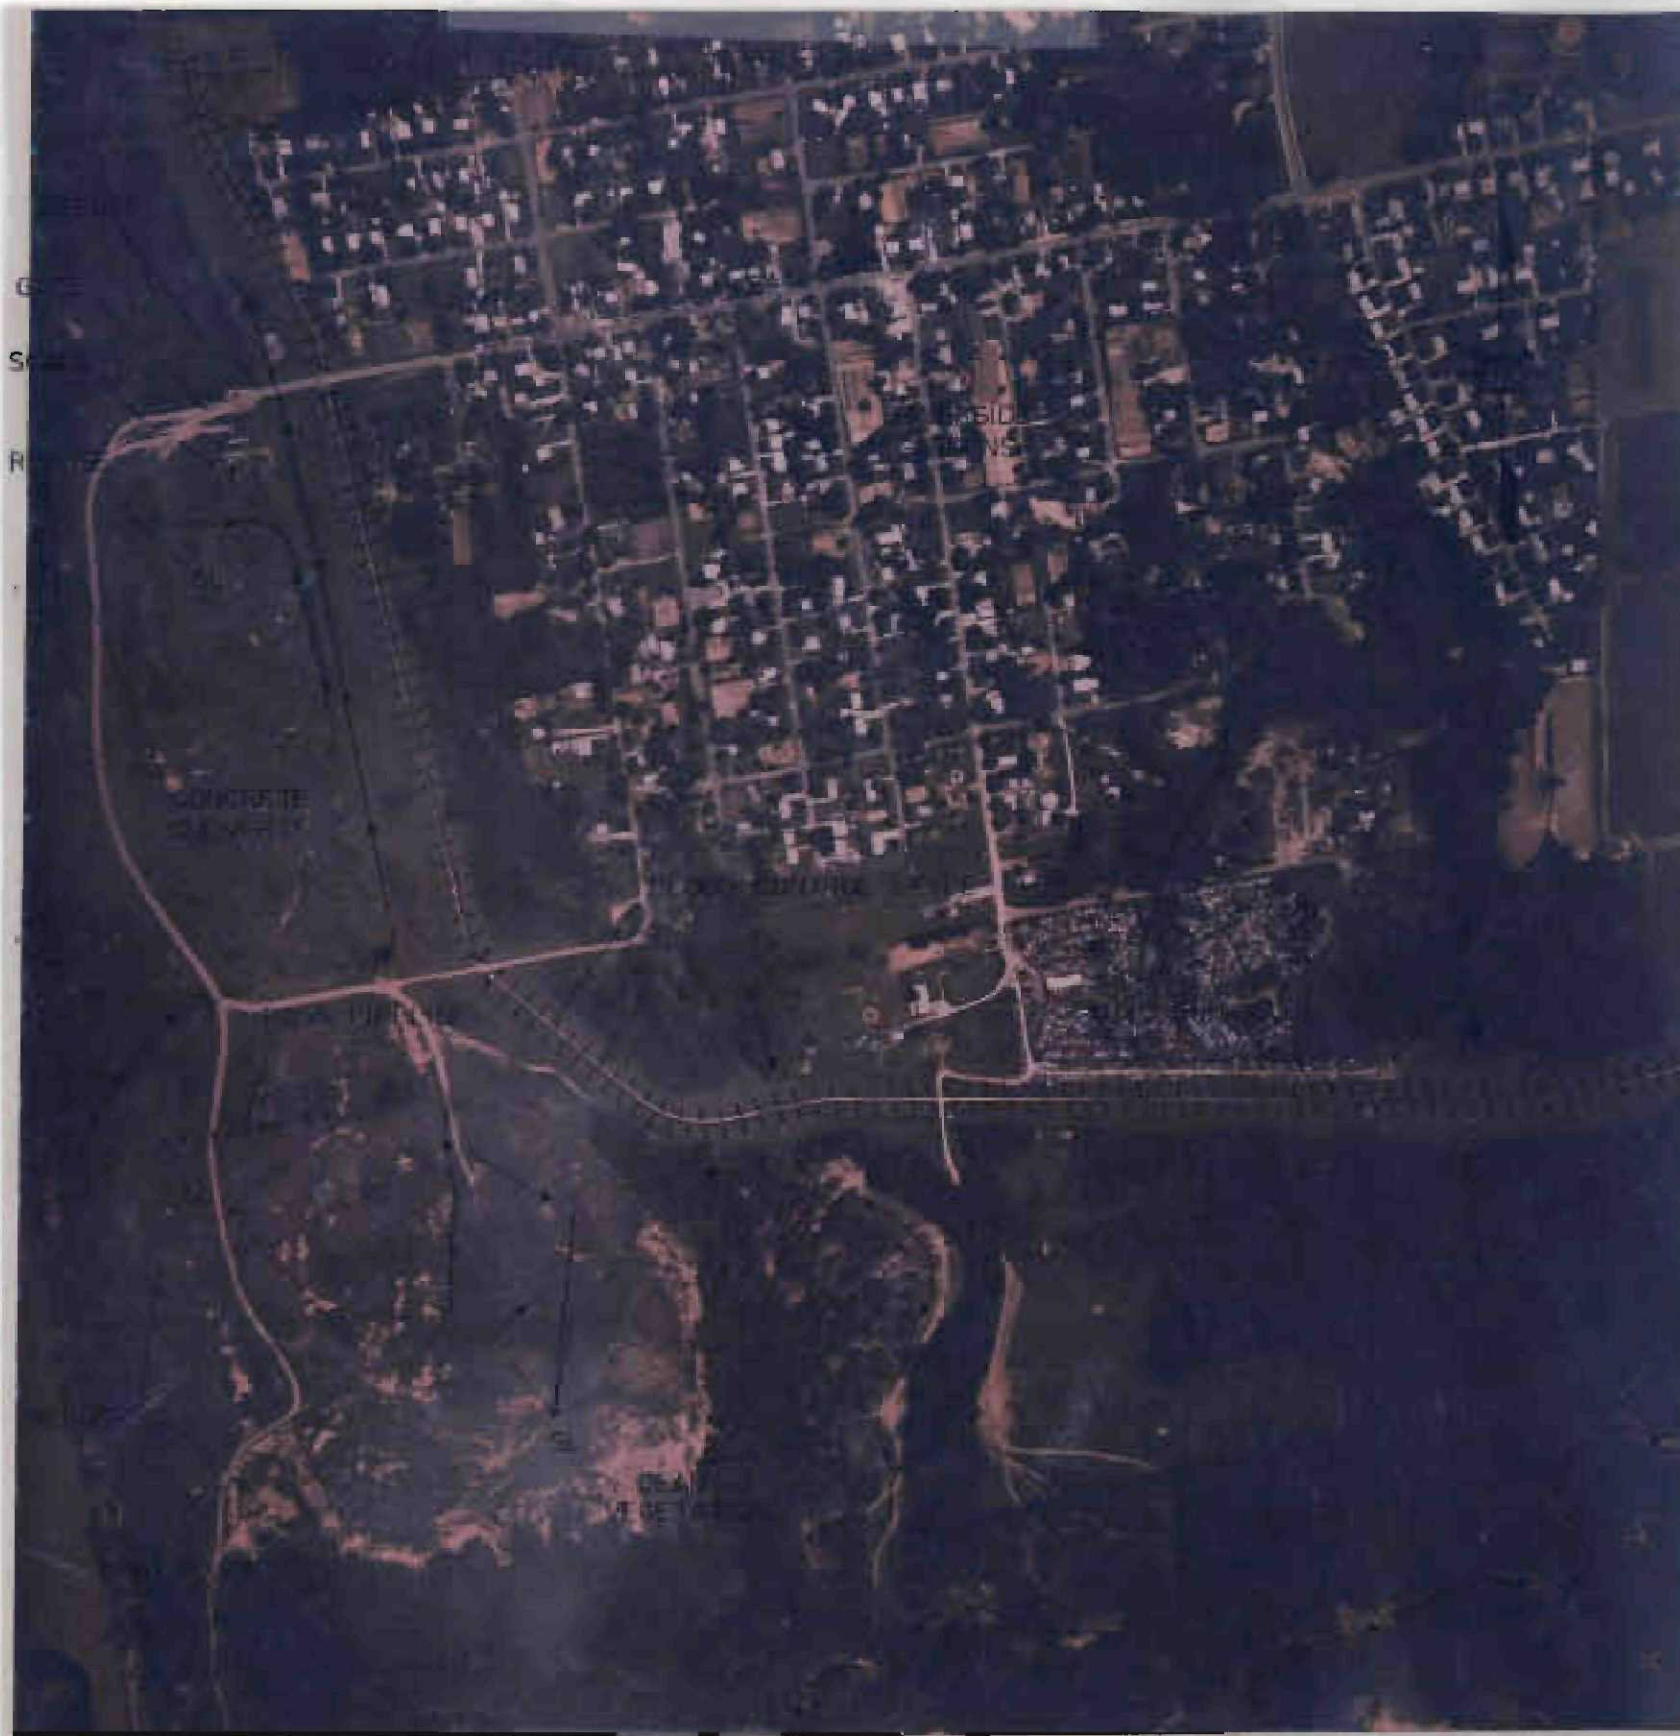
LEE'S LANE LANDFILL JUNE 15, 1979 APPROX. SCALE 1:6,000

This color photo of the landfill shows the site to be inactive and revegetating. The surface of the landfill appears highly pitted and ungraded and contains numerous ground scars and bodies of standing liquid (SL). These features, which appear primarily in the southern portion of the site, do not appear to denote any particular hazard. One notable exception, however, is a body of standing liquid located near the center of the site. A possible pipeline (annotated on the photo) appears to run from this body of liquid towards the Ohio River. The terminus of this possible pipeline could not be located at the bank of the river.

Small deposits of municipal (household) waste, concrete culverts and additional debris have been detected along the northern and western flanks of the landfill. These deposits appear to be remnants of historic as well as recent dumping activity. No detectable hazard was associated with these deposits.

The drainage pattern formed in the vicinity of the landfill appears little changed from its past configuration. Several small drainage channels have been detected within the landfill; however, these appear to be very localized and intermittent in nature.
